# TREES AND THEIR EFFECTS ON BUILDINGS

JIM Y.O. LOKE BSc, BE (Hons), PhD, FIEAUST, CP ENG  
Principal Engineer, Design and Services, NSW Public Works Department

#### CASE STUDY OF BUILDING DAMAGED BY TREES

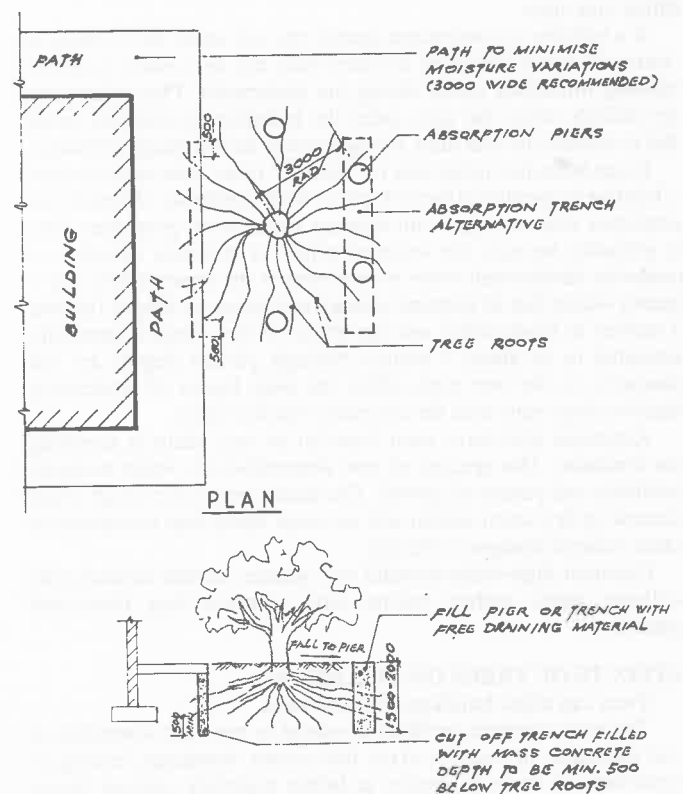
FIGURE 1

a) **Cut off trenches** (Figure 1) to below tree root level. The trench would normally be placed at the edge of the canopy to minimise tree root damage.

The cut off trench would be maximum of 3 metres deep and of mass concrete or sheet piling.

b) **Absorption trenches/piers** (Figure 1) filled with free draining materials and surface drainage directed to these areas, to encourage root growth away from buildings. During times of drought watering should be directed into these areas. Also, if desired, water from sinks (not toilets) could be fed to these trenches.

#### SECTION CUT OFF TRENCH & ABSORPTION PIER/TRENCH DETAILS

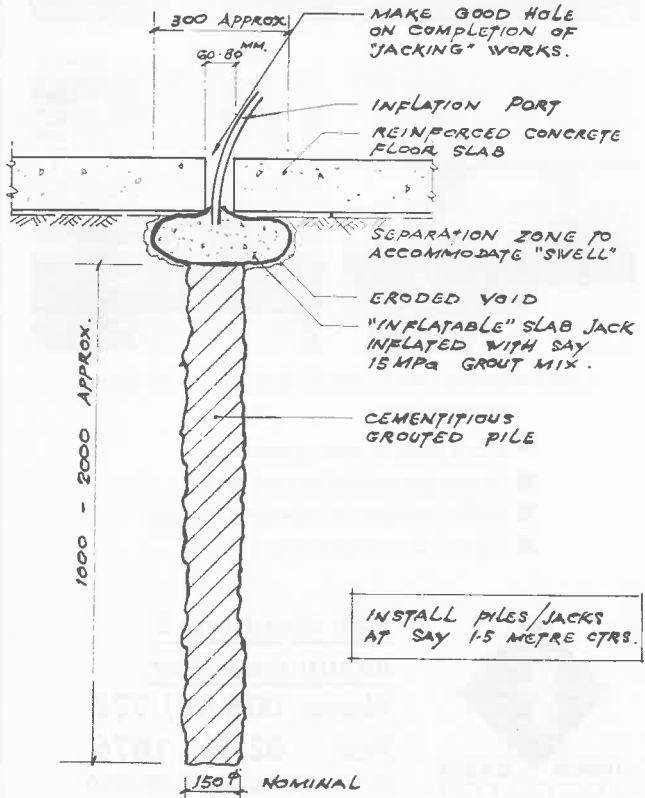
UNDERPINNING/SLAB JACKING PROPOSAL  
FIGURE 3 - CASE STUDY

Various remedial options were considered, though a cut off trench was not considered because of the closeness of the trees to the building and the nearby sewer main. The normal option would be to remove the trees and wait for foundations to moisten and stabilise. But in this case the client was not willing to wait months or even years for the walls to be repaired and so the following innovative remedial works were recommended (and are awaiting client approval):

- a) Remove trees.
- b) Underpin north west area of the building using small diameter grout injected mini piles at close centres under the slab (Figure 3).
- c) Jack up building to level using grout filled bags (the gap formed underneath will allow for expansion of the foundations).
- d) Repair walls and make good slab.
