# TREES AND THEIR EFFECTS ON BUILDINGS

JIM Y.O. LOKE BSc, BE (Hons), PhD, FIEAUST, CP ENG  
Principal Engineer, Design and Services, NSW Public Works Department

#### CASE STUDY OF BUILDING DAMAGED BY TREES

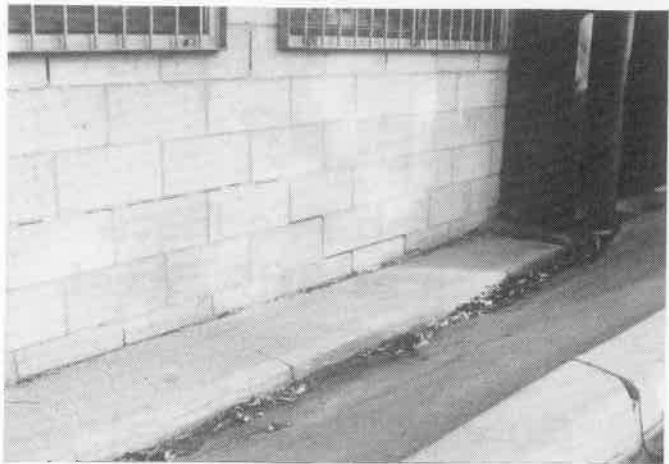
When the building was inspected in July 1990 only minor cracking was noted in the walls at the north west corner (Photo 1). In March the following year the building was again inspected as cracking had significantly increased. This inspection found that the cracks in the north west corner had opened to about 30mm in June 1991 (Photo 2) and that external and internal walls were showing great distress.

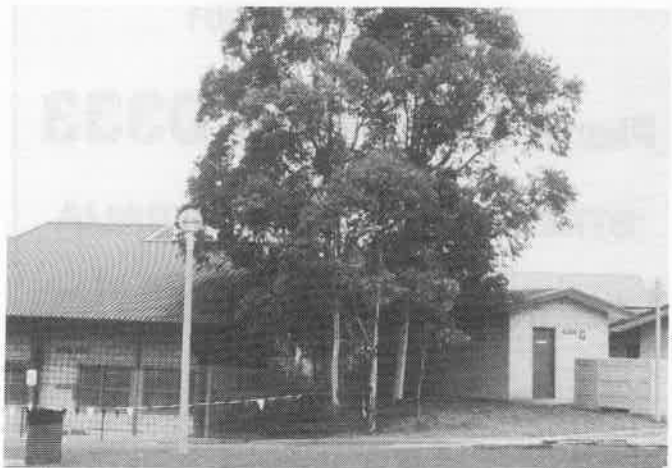
A clump of eucalyptus trees (Photo 3) was found to be growing some 2 to 6 metres away from the corner of the building. The tallest was some 10 metres in height. The trees were identified as a possible cause of cracking but other potential causes such as cracked pipes and/or poorly compacted foundations had to be also investigated.

The pipes were checked and found to be satisfactory and a geotechnical investigation found the building to be on natural ground and that tree roots were going under the building. Investigations indicated that the trees were planted about 1985 and that growing conditions have generally been good so the trees grew quickly with the availability of moisture, but are yet to attain maturity. Because of the good conditions moisture variations in the foundations were minimal. The conditions since July 1990 were exceedingly dry and so the tree roots have removed moisture from the foundations and caused shrinkage. This resulted in settlement of the slab and cracking of the walls.

Various remedial options were considered, though a cut off trench was not considered because of the closeness of the trees to the building and the nearby sewer main. The normal option would be to remove the trees and wait for foundations to moisten and stabilise. But in this case the client was not willing to wait months or even years for the walls to be repaired and so the following innovative remedial works were recommended (and are awaiting client approval):

- a) Remove trees.
- b) Underpin north west area of the building using small diameter grout injected mini piles at close centres under the slab (Figure 3).
- c) Jack up building to level using grout filled bags (the gap formed underneath will allow for expansion of the foundations).
- d) Repair walls and make good slab.
